## Repairing the Aubecken pumped-storage reservoir with an impermeable core using a Mixed-in-Place method

Tobias Gebler, Roland Hoepfner and Daniel Sabo

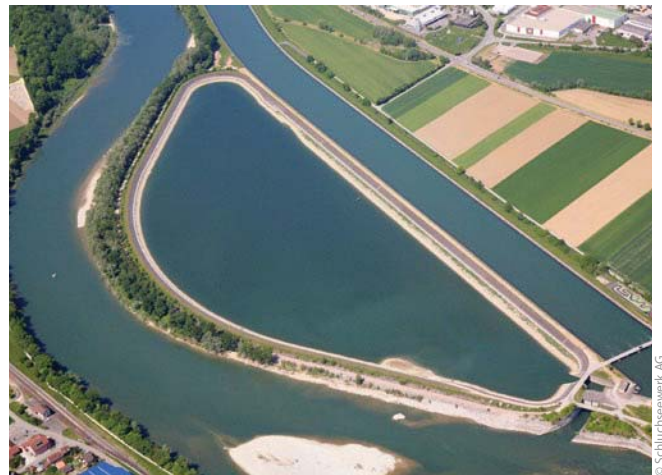
Since operation began, seepage measurements taken within the circumferential drainage system have revealed considerable shortcomings on the part of the sealing system. Partial rehabilitation projects in the 1980s and 1990s involving the diaphragm wall joints and underground grouting did not yield lasting success.

Exceptionally high seepage occurred when the reservoir level was high, especially during the winter. In turn, this sometimes even led to pressurised conduit flow in the drainage pipes. In addition, groundwater levels observed in the vicinity of the reservoir varied considerably by several metres, depending on reservoir management. Sand deposits were also found during regular inspections of the circumferential drainage system's seepage shafts. Regular precise surveys of the encircling dam revealed advancing settlement behaviour, especially in the separating dam. The conclusion that was drawn was that distinct flow conditions in the subsoil or in the body of the dam was causing material to shift.

Extensive measuring campaigns and expert opinions indicated that seepage was occurring, especially in the diaphragm wall joints and in the area where the diaphragm wall met the bedrock. Safeguarding the durability of the separating dam in the long term without restricting operations was therefore no longer guaranteed. The decision was made to undertake an extensive rehabilitation of the reservoir's sealing system near the separating dam so as to minimise the risk of an unscheduled stoppage and limitations on reservoir management.

Figure 1: Aerial view of the Aubecken

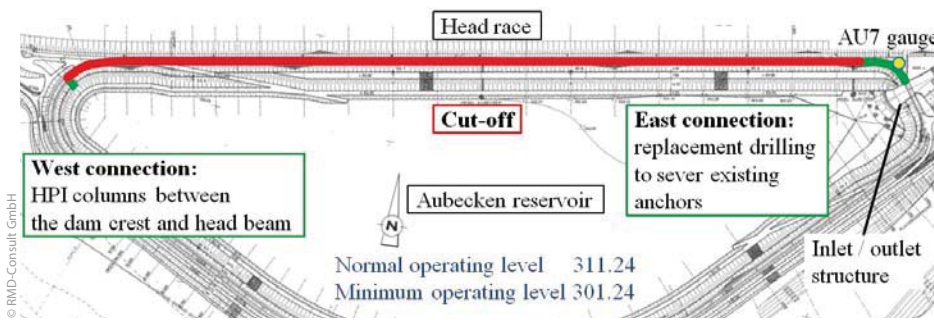
Figure 2: Site plan for the Aubecken rehabilitation project

Broadly in keeping with the feasibility study, the tender documents provided for rehabilitation of the entire separation dam between the transition to the encircling dam in the west and the intake/outlet structure in the east of the reservoir using a sheet pile cut-off about 980 metres long going between 12 and 20 metres deep. This cut-off wall was to be located as close as possible to the dam shoulder on the Aubecken reservoir side due to the large number of power and other cables in the dam crest area. **Figure 2** shows a site plan for this project, while **Figure 3** depicts a standard cross-section.

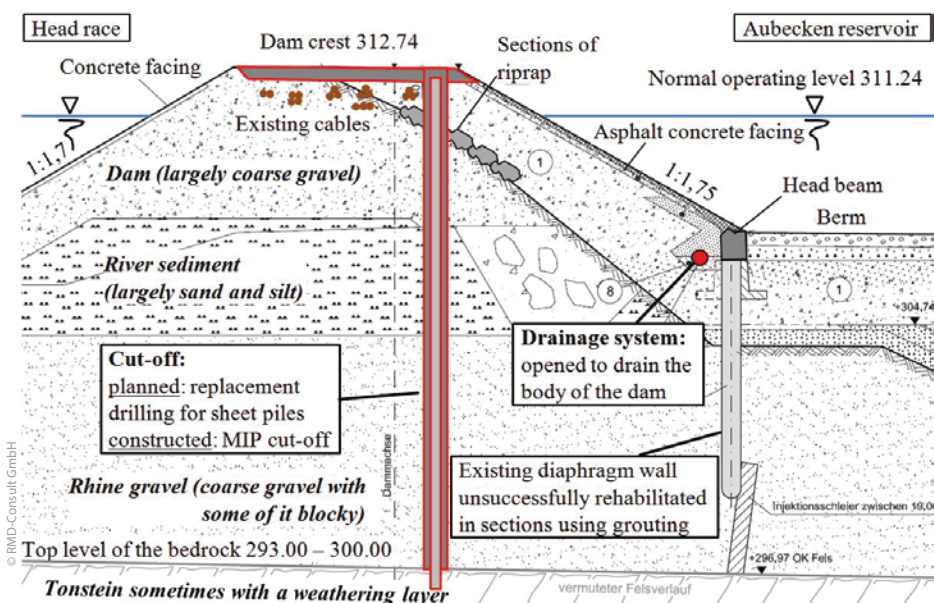
In addition to performing drilling, seven heavy ram probes were sunk in advance of work to complete the geotechnical survey. However, just two of these probes reached the bedrock level and thus the expected final depth. Subsoil areas were addressed as follows with the help of all available geotechnical documents (Figure 3):

- Embankment: Coarse gravel with rocky formations.
- Recent fluvial deposits: Sandy to silty
- Rhine gravel: Coarse gravel, some of it block-like
- Bedrock: Tonstein with a weathering horizon of a few decimetres

Figure 3: Standard cross-section of the Aubecken rehabilitation project

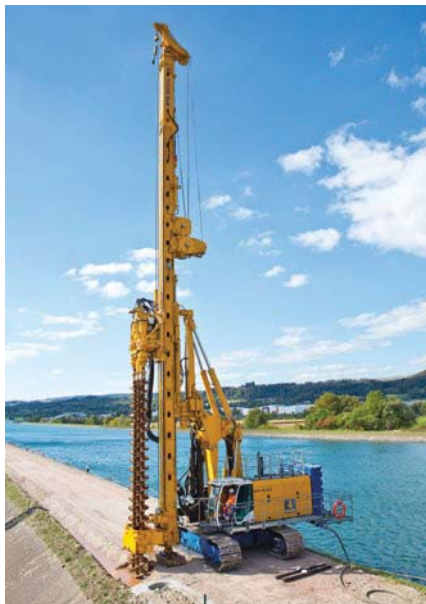
**Figure 4:** Manufacturing of the Mixed-in-Place cut-off using a RTG RG 25 rig with a triple auger

broken up using a triple auger before working in the binder suspension. The triple auger drills down to the final depth as the suspension is added. During the subsequent homogenisation process, each auger's rotational direction is varied in such a way that a vertical material cycle is created in the MIP cut. **Figure 4** shows the MIP device in operation at the Aubecken dam.

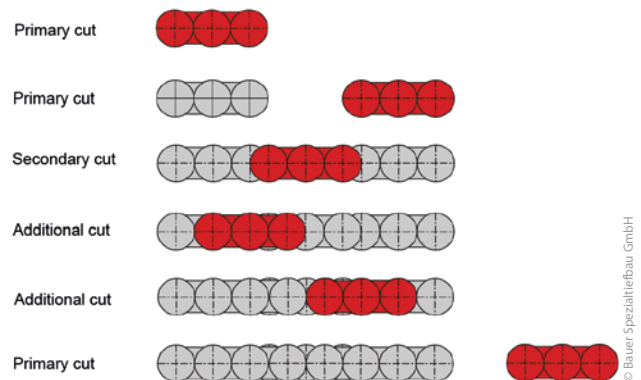
**Figure 5:** Sequence of the double pilgering method in the MIP process

The MIP cut-offs are made using a double pilgrim step process in order to make sure that the wall is continuous and seamless. This patented process also features additional processing of the overlap areas comprising primary and secondary cuts. This ensures that the triple auger penetrates and mixes each wall element at least twice (**Figure 5**).
