Construction of the Plastic Concrete Cut-off Wall at Hinze Dam

Plastic Concrete Cut Off Wall

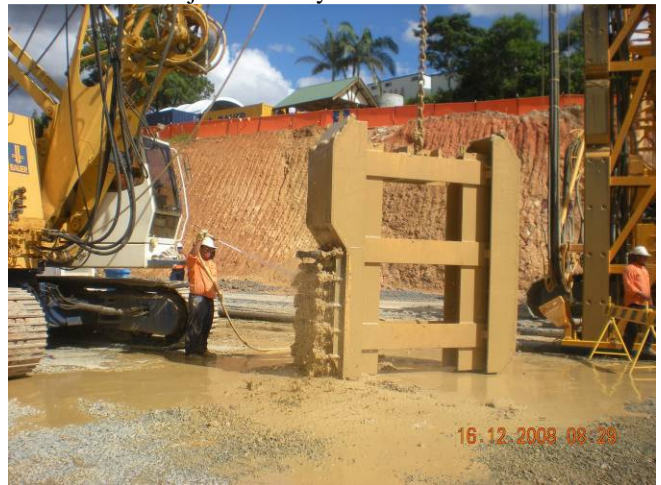
Plate 5 – Cleaning Brush for Joints

This method proved to be very successful. A number of joints were exposed following completion of the wall, the quality of the joints meant that it was typically difficult to detect where the joint actually was.

- After completion of excavation of the panel, the majority of the working bentonite within the trench is replaced with a more viscous bentonite.
- The sides of the adjacent primary panels are cleaned using the brush shown in Plate 5. This device is slightly wider than the cutter so that the brushes scrape down the side of the panel. The brush is also pulled across by the crane to the side being cleaned to ensure the brushes are bearing on the side of the panel.
- The trench cutter is then sent back down the secondary panel to clean any material from the base of the panel and to replace the bentonite

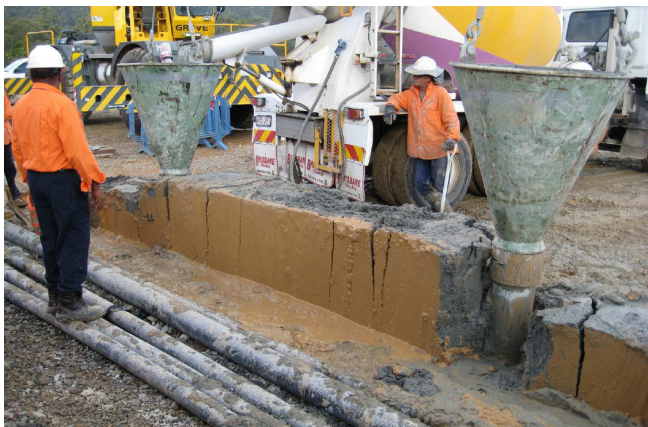
Plate 7 – Panel 25 Concrete Pour

During the pouring of the initial primary panels, it was observed that the concrete at the top of the panel appeared cohesive, see Plate 7, and was extruded up between the guidewalls. At times this meant the concrete could not be pushed out of the top of the panel or pushed out over the full width of the panel. Investigations and testing into the reasons for the cohesive concrete included the following:

From further investigations it was determined that over the time it takes to pour an entire primary panel, typically 6 to 8 hours, the concrete was going through its initial set and therefore appeared to be cohesive/stiff at the surface of the panel. The testing of the cohesive concrete and observations made gave no suggestions that there were any adverse effects to the concrete. The main concern was that the concrete extends to the full width and length of the panel to fill in any voids, particularly for the secondary panels.

To ensure that there were no joints or defects in the cohesive concrete, the top 5 to 6m of each of the secondary panels was excavated by the grab without the use of bentonite. This meant that the sides of each of the primary panels could be visually inspected. A couple of minor joint defects were found in the top portion of two of the panels. However as the top 1.5m of the wall was to be removed prior to construction of the overlying embankment, the defects would be removed.

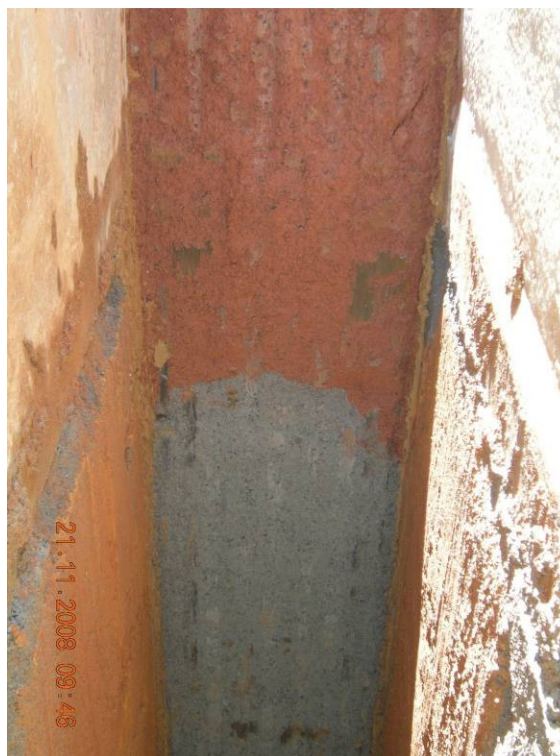
Plate 8 – Dye testing of concrete

It was determined that it was the concrete from the initial trucks that gets pushed to the surface of the panel. This effect can be seen in Plate 8 where the red dyed concrete from the initial trucks is clearly apparent above the later non dyed concrete.

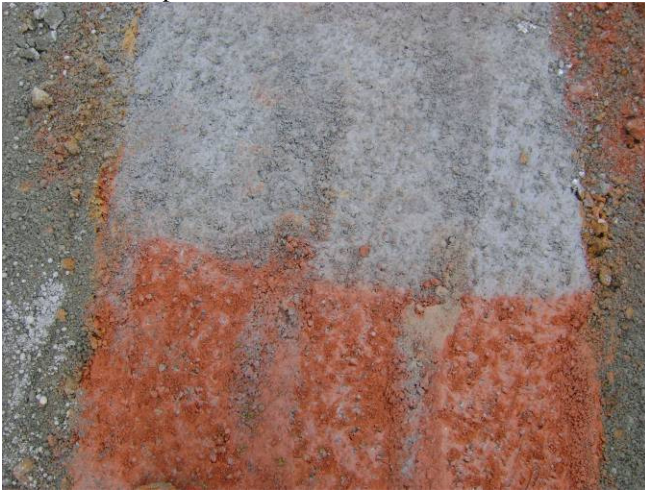
Plate 9 – View of joint between primary and secondary panels

inspection of the joints within the wall. It was typically difficult to detect the position of the joint which indicated that the cleaning process was effective in removing any excess bentonite. The quality of the joints can be seen in Plate 9 which shows the joint between a panel with dyed concrete and a panel without.
