A PERMANENT CONCRETE CUT-OFF WALL FOR THE BAGATELLE DAM, MAURITIUS – CHALLENGES AND LESSONS LEARNED

P Banzhaf¹, K Beckhaus¹, M Baltruschat¹

1. Bauer Spezialtiefbau GmbH, Schrobenhausen, Germany

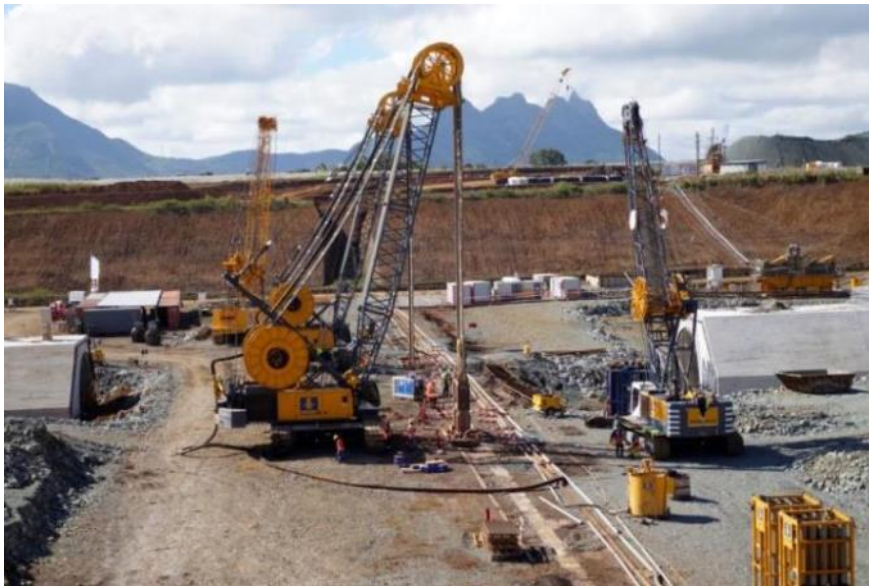
Figure 1 BAUER Trench-Cutter and Grabs along the CCOW installation

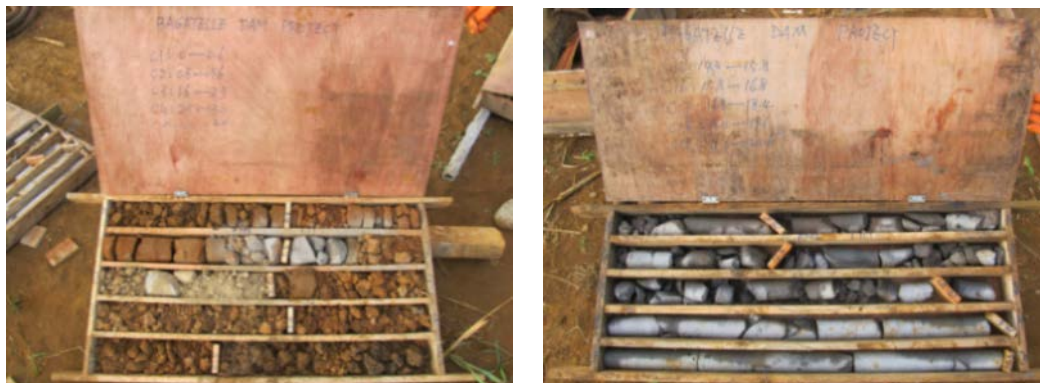
Figure 2 Core boxes showing weathered basalt with some cobbles (left) and fresh competent basalt (right)

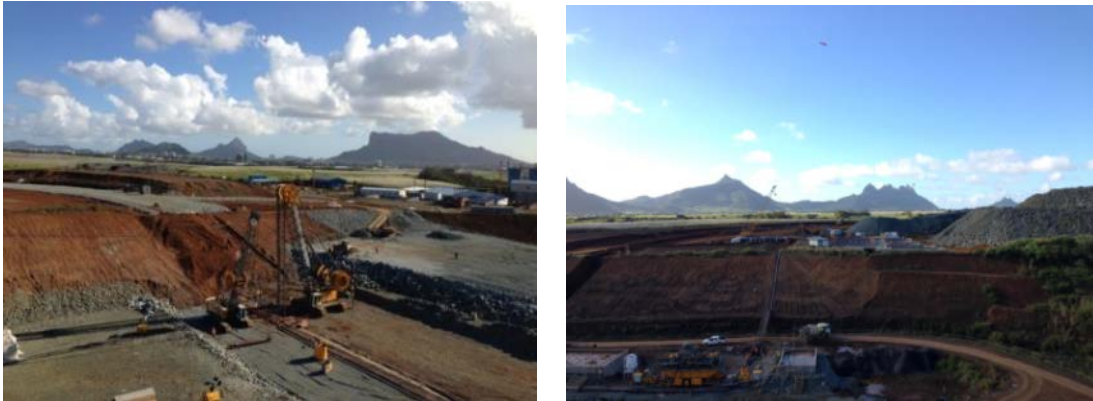
Figure 10 Changes in elevation Central Part to Left and Right Banks

At the Central Part the working platform elevation was at EL 360 m whereas the platform at the adjacent Left Bank was at approx. EL 372 m and at the Right Bank at approx. EL 375 m.
