Cut-off Wall at Tight Site in the Himalayas

The Punatsangchhu-1 hydro-electric project (PHEP) is one of 10 hydropower plants being built as part of extensive infrastructure development in Bhutan, a landlocked state bordered by India and China. The 1,200 megawatt project will supply the nation with electricity, and some will be sold to nearby India. The dam is notable because of the steep constrained site and the difficulty of construction; in spite of which the dam was built on time and on budget. State-of-the-art hydro cutters were a major factor in this successful project.

The Punatsangchhu Hydro Electric Project Authority of Bhutan is coordinating the entire project and will also be responsible for the subsequent Punatsangchhu-2 hydro electric project further downstream. Larsen & Toubro Ltd. (L&T), Chennai, India, was the contractor for the main dam for PHEP-1. In 2011, Bauer Spezialtiefbau GmbH received the contract for a concrete cut-off wall for the cofferdam upstream.

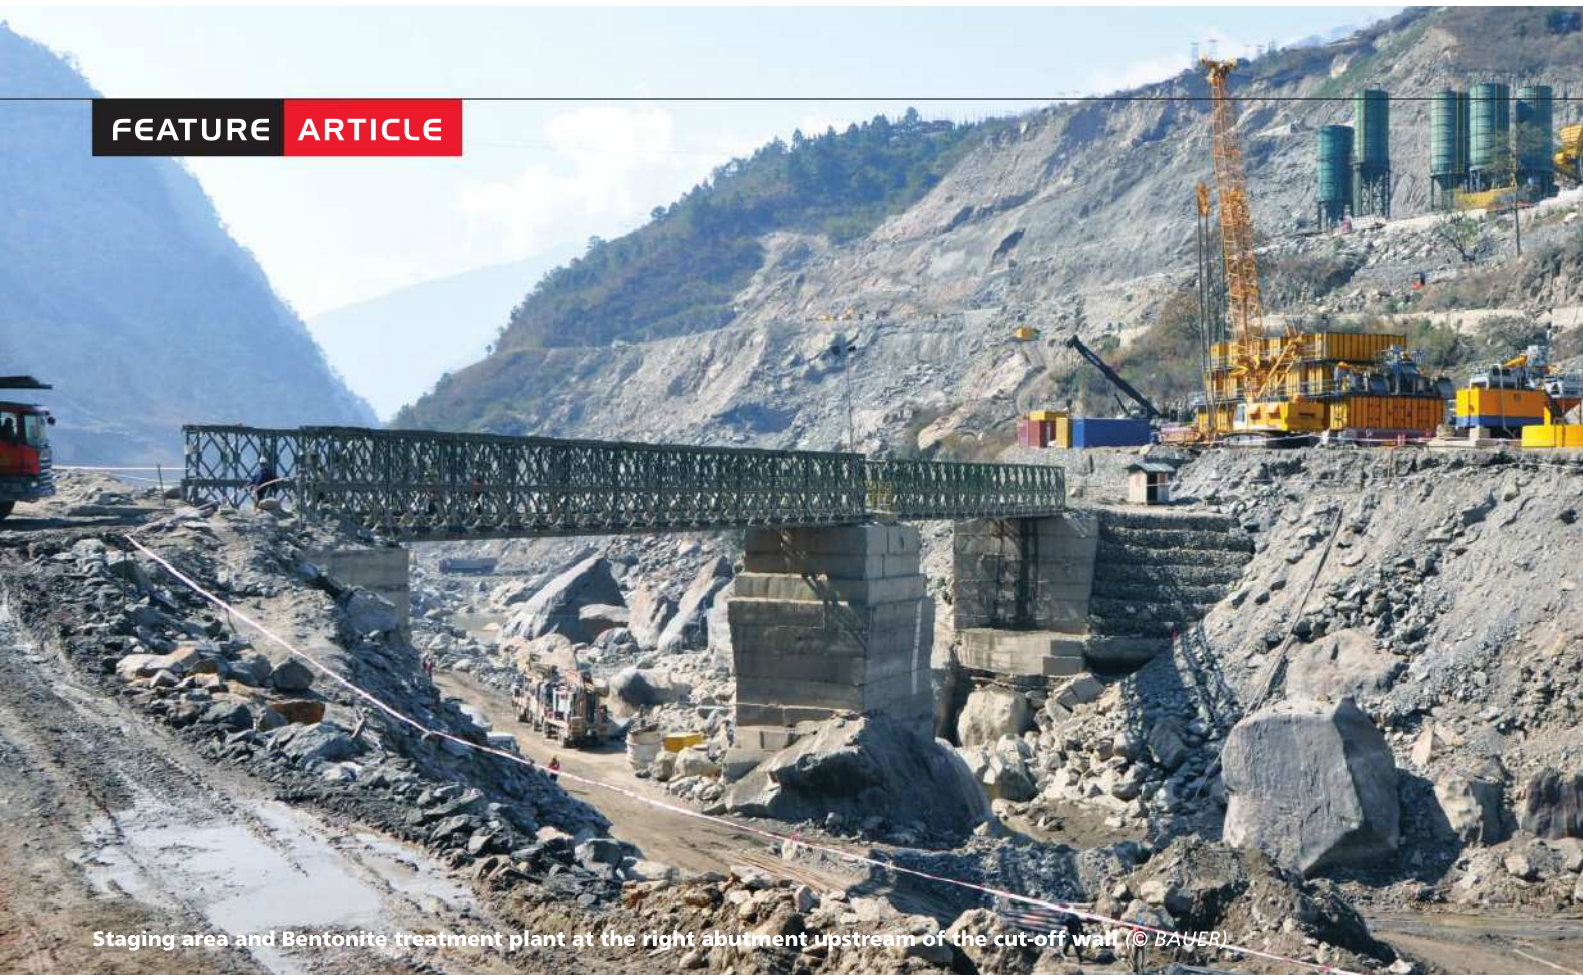
Staging area and Bentonite treatment plant at the right abutment upstream of the cut-off wall. © BAUER

On a reinforced concrete slab 150 m (492 ft) away from the work platform, Bauer built a bentonite mixing plant and a regeneration plant for two cutter units and a grab. Steel containers and two circular in-situ concrete basins for fresh bentonite, concreting bentonite and working bentonite, were provided for stock-keeping. The contractor also ensured constant power supply by providing generators. Bentonite slurry was produced by two mixers and recycled by two desanding units for the two cutters. A third

desanding unit served as a replacement and also cleaned the slurry, which was pumped back during concreting or grabbing.

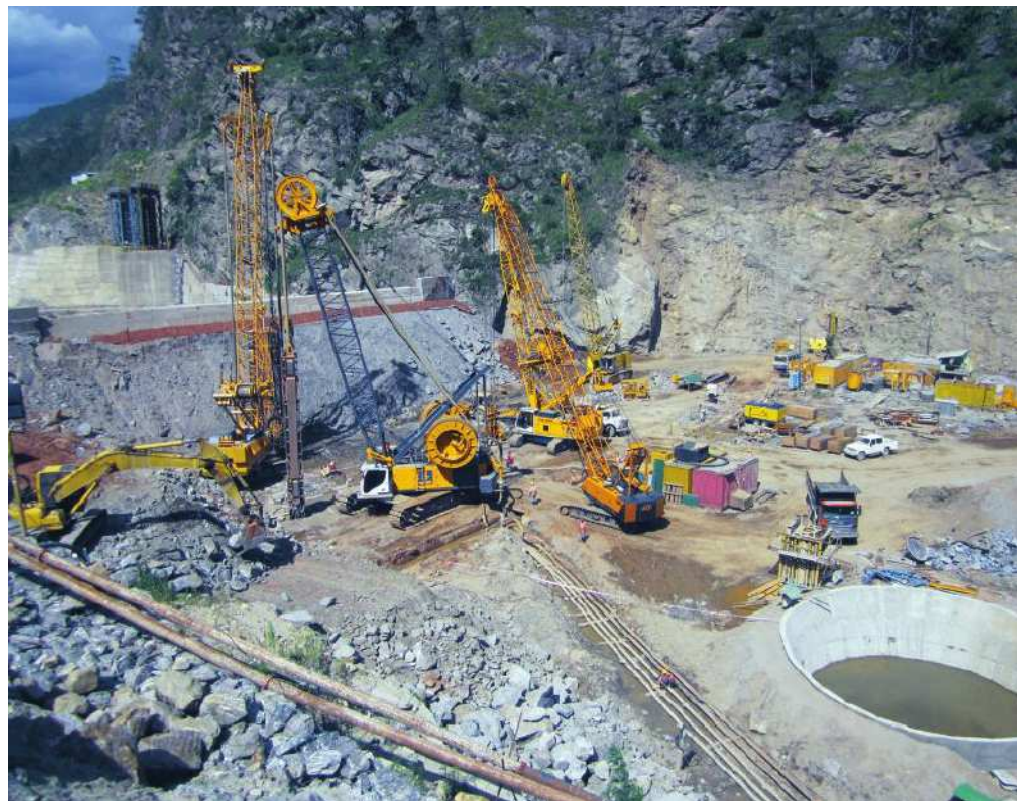
The concrete cut-off wall with two BAUER Trench Cutters, one BAUER Hydraulic Grab and support cranes (© BAUER)

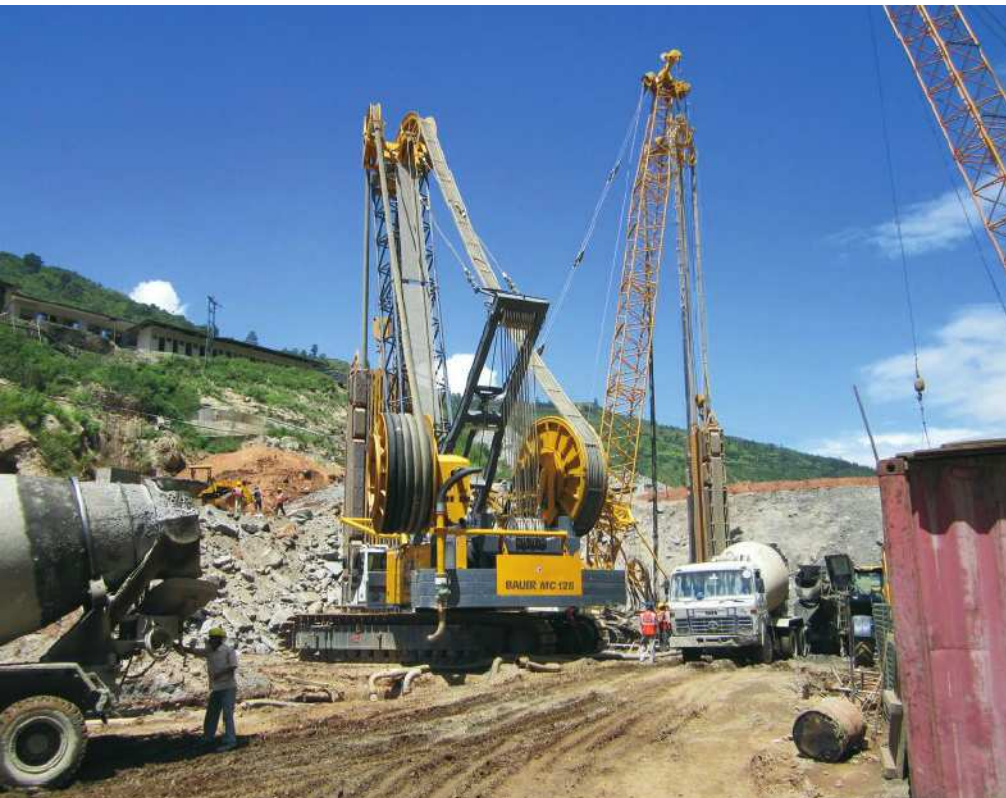
BAUER MC 128 and Trench Cutter BC 40 (© BAUER)

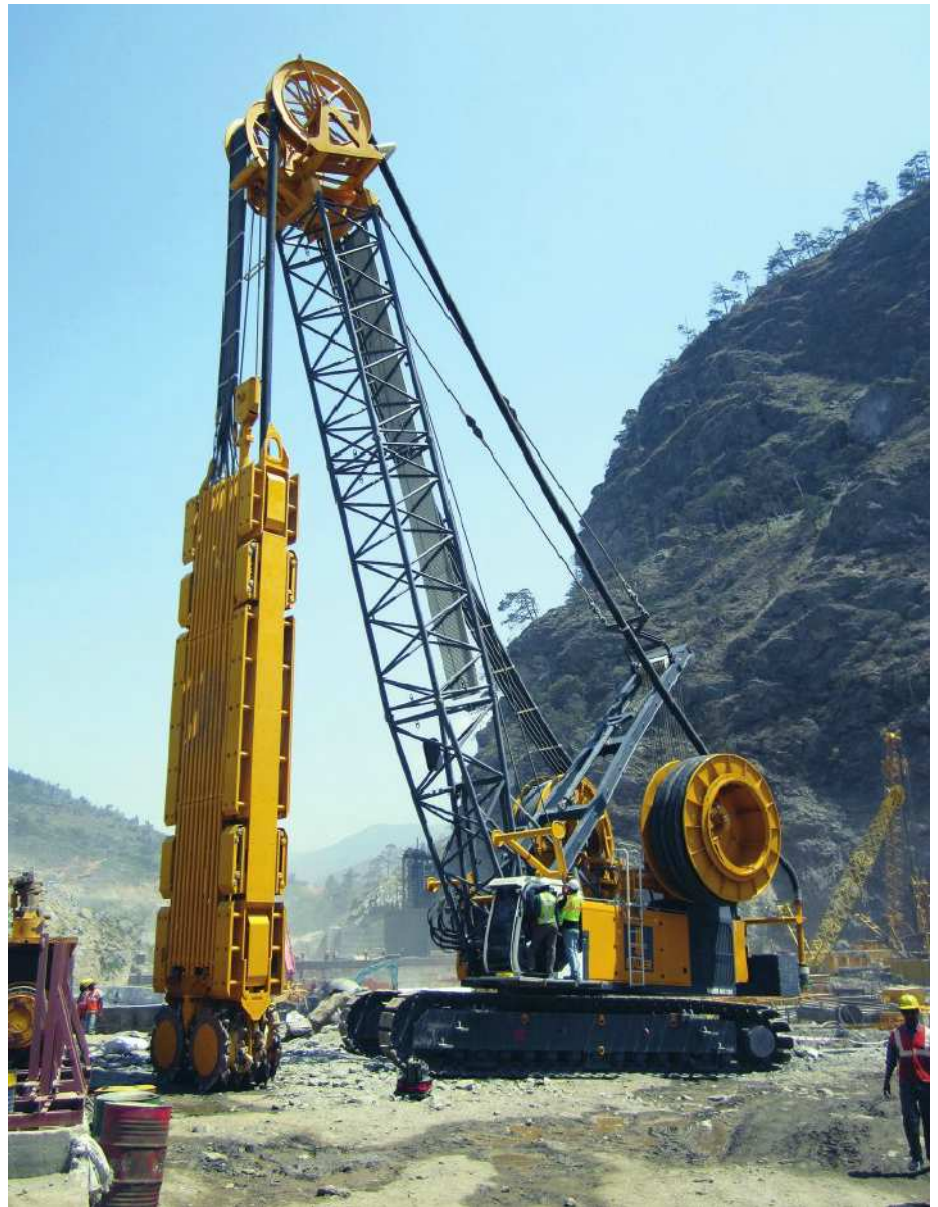
BAUER MC 128 Base machine with HDS and Trench Cutter BC 40 rigged up for rock cutting to depths of more than 100 m (328 ft) (© BAUER)
